**Flood Control Project Maintenance
Levee Inspections**

Maintenance Issue Types Only, Levee Inspection Report By Mile - Spring 2016

Reclamation District No. 0536 Egbert

Waterway	Bank	Unit Miles	Inspection Start/End	Inspector
Unit No. 01 Lindsey Slough	Right	5.58	03/30/2016 03/30/2016	Herman Phillips

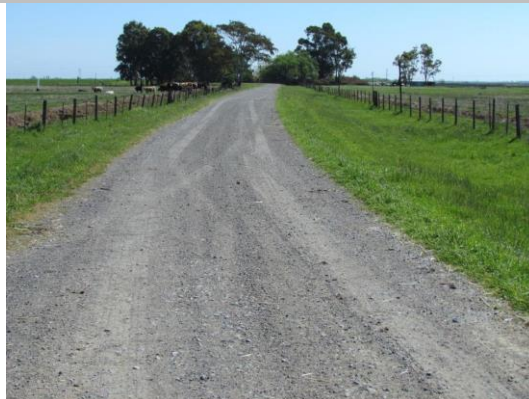
Photo 1 of 1 : SP_2016_RD0536_208_21_20160516_00040.jpg

LM Start	0.02	Rating **	A/W	Issue No.	21
LM End	1.05	Issue Type +	Ma	Location *	LS
Category	Earthen Levee			GPS Latitude/Longitude	
				Start	End
Item	Vegetation			38.244968 °	38.254798 °
				-121.768630 °	-121.757680 °
DWR ID	DWR_RD0536_01_f_2015_21				
Comment Code					
V1 : Control annual grass and weeds on the levee slopes and easements.					
Inspector Comment					
Looking downstream from levee mile 0.02-1.05 no vegetation problems.

RD 536 Unit 1 looking downstream from levee mile 0.02 to 0.22.

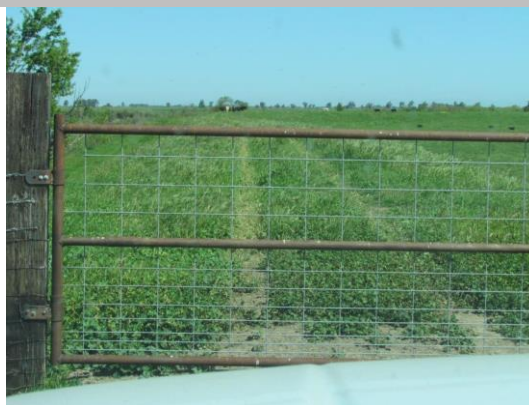
Photo 1 of 1 : SP_2016_RD0536_208_31_20160516_00046.jpg

LM Start	1.10	Rating **	U	Issue No.	31
LM End	2.60	Issue Type +	Ma	Location *	CR
Category	Earthen Levee			GPS Latitude/Longitude	
				Start	End
Item	Vegetation			38.255475 °	38.256395 °
				-121.757598 °	-121.738608 °
DWR ID	DWR_RD0536_01_s_2016_31				
Comment Code					
V9 : Keep the crown roadway free of vegetation.					
Inspector Comment					
Remove the tall weeds from the crown roadway, the crown should be free of vegetation.

RD 536 Unit 1 looking downstream from levee mile 1.10 - 2.60 tall weeds growing on the crown roadway.

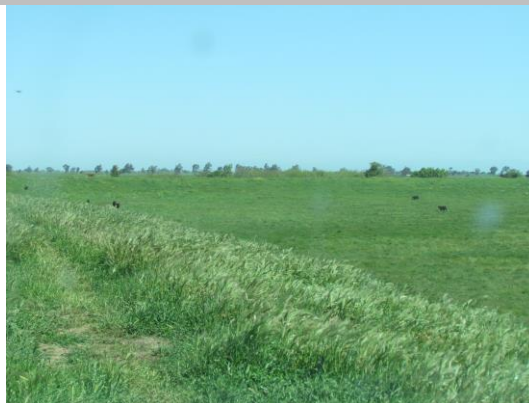
Photo 1 of 1 : SP_2016_RD0536_208_32_20160516_00043.jpg

LM Start	1.11	Rating **	U	Issue No.	32
LM End	5.57	Issue Type +	Ma	Location *	LS
Category	Earthen Levee			GPS Latitude/Longitude	
				Start	End
Item	Vegetation			38.255533 °	38.245595 °
				-121.757595 °	-121.697653 °
DWR ID	DWR_RD0536_01_s_2016_32				
Comment Code					
V2 : Remove the wild growth other than native grasses from the levee slopes.					
Inspector Comment					
Remove the tall grasses from the landside levee slope.

RD 536 Unit 1 looking at the landside slope from levee mile 1.11- 5.57 the tall grasses completely covering the levee slope.

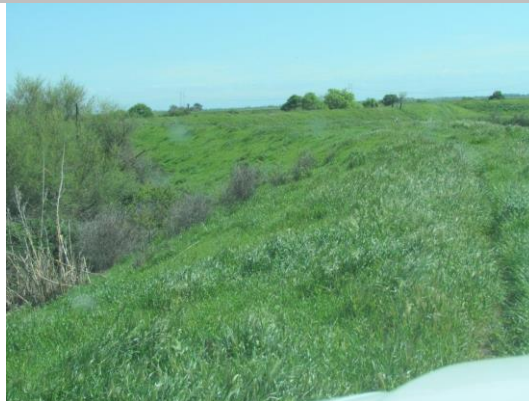
Photo 1 of 1 : SP_2016_RD0536_208_34_20160516_00044.jpg

LM Start	1.15	Rating **	U	Issue No.	34
LM End	4.25	Issue Type +	Ma	Location *	WS
Category	Earthen Levee			GPS Latitude/Longitude	
				Start	End
Item	Vegetation			38.256246 °	38.248888 °
				-121.757581 °	-121.718091 °
DWR ID	DWR_RD0536_01_s_2014_34				
Comment Code					
V2 : Remove the wild growth other than native grasses from the levee slopes.					
Inspector Comment					
Remove the unwanted tall grasses, arundo and other wild growth from the waterside levee slope and toe

RD 536 Unit 1 levee mile 1.15-4.25 tall grasses and other wild growth covering the waterside slope and toe.

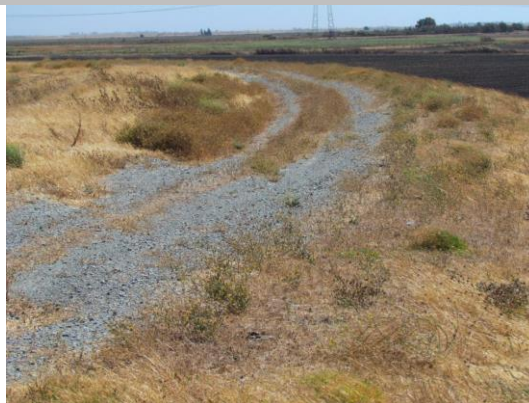
Photo 1 of 3 : SP_2016_RD0536_208_56_20160223_00009.jpg

LM Start	2.69	Rating **	U	Issue No.	56
LM End	2.71	Issue Type +	Ma	Location *	CR
Category	Earthen Levee			GPS Latitude/Longitude	
				Start	End
Item	Crown Surface / Depressions / Rutting			38.255197 °	38.254973 °
				-121.737932 °	-121.737577 °
DWR ID	DWR_RD0536_01_f_2014_56				
Comment Code					
C1 : Add appropriate material and re-grade the levee to bring the crown above the design elevation.					
Inspector Comment					
District need to monitor the levee crown roadway at this location. There are some issues here. This will involve more than adding material. What's causing the separation needs to be examined.

Looking downstream at crown roadway there is still some settling going on here at this location.

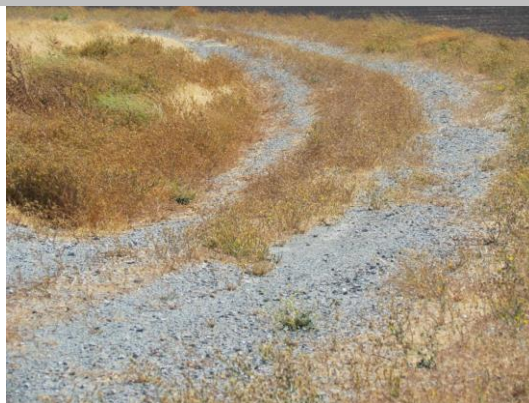
Photo 2 of 3 : SP_2016_RD0536_208_56_20160223_00010.jpg

Close up view of the uneven settling of the crown roadway.

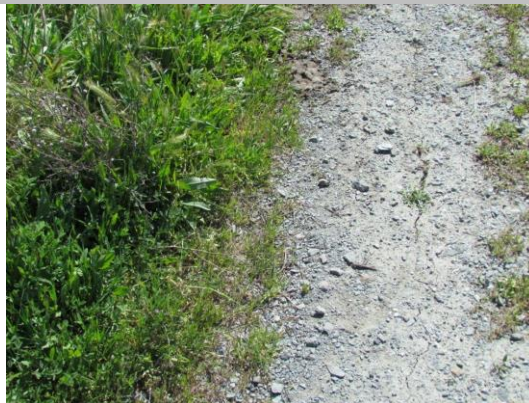
Photo 3 of 3 : SP_2016_RD0536_208_56_20160516_00041.jpg

The crown roadway has some settling issues that can't be viewed due to the tall grasses allowed to grow on the crown.

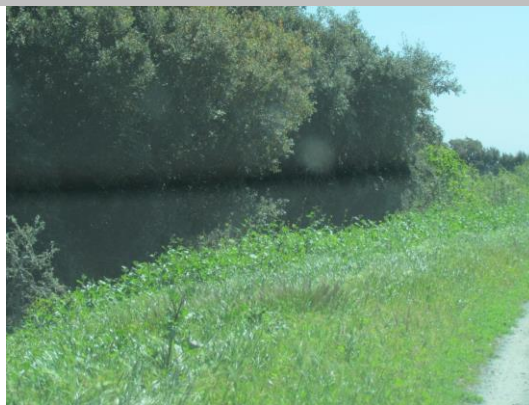
Photo 1 of 1 : SP_2016_RD0536_208_44_20160516_00045.jpg

LM Start	4.55	Rating **	U	Issue No.	44
LM End	4.96	Issue Type +	Ma	Location *	WS
Category	Earthen Levee			GPS Latitude/Longitude	
				Start	End
Item	Vegetation			38.249110 °	38.245648 °
				-121.713052 °	-121.708125 °
DWR ID	DWR_RD0536_01_s _ 2016_44				
Comment Code					
V2 : Remove the wild growth other than native grasses from the levee slopes.					
Inspector Comment					
Remove the wild growth from the water side levee slope and toe levee mile 4.55 to 4.96.

RD 536 Unit 1 looking downstream from levee mile 4.55-4.96 unwanted tall weeds covering the waterward slope and toe.

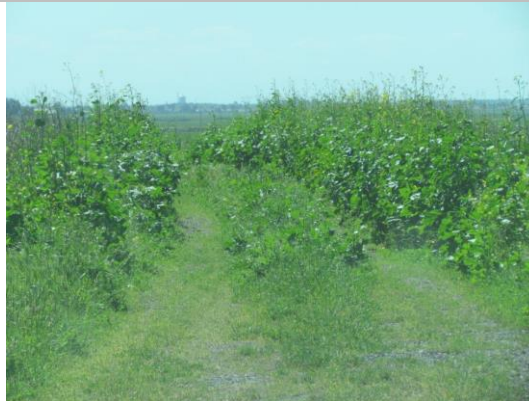
Photo 1 of 1 : SP_2016_RD0536_208_45_20160516_00047.jpg

LM Start	4.61	Rating **	U	Issue No.	45
LM End	4.96	Issue Type +	Ma	Location *	CR
Category	Earthen Levee			GPS Latitude/Longitude	
				Start	End
Item	Vegetation			38.248548 °	38.245648 °
				-121.712273 °	-121.708125 °
DWR ID	DWR_RD0536_01_s _ 2016_45				
Comment Code					
V9 : Keep the crown roadway free of vegetation.					
Inspector Comment					
Remove the unwanted tall weeds from the crown roadway as the crown should be free from vegetation.

RD 536 Unit 1 looking downstream from levee miles 4.61 to 4.96 weeds taller than 5-foot growing on the crown roadway.

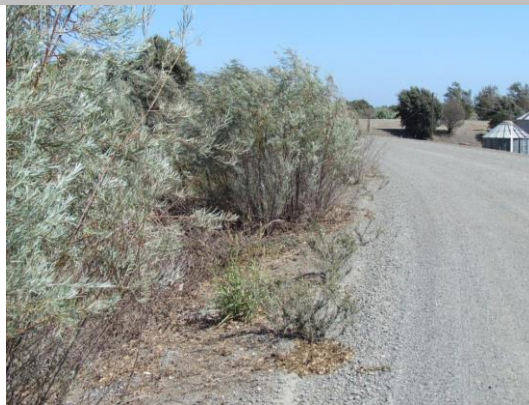
Photo 1 of 1 : SP_2016_RD0536_208_70_20160223_00012.jpg

LM Start	5.45	Rating **	U	Issue No.	70
LM End	5.53	Issue Type +	Ma	Location *	WS
Category	Earthen Levee			GPS Latitude/Longitude	
				Start	End
Item	Vegetation			38.245565 °	38.245503 °
				-121.699808 °	-121.698480 °
DWR ID	DWR_RD0536_01_f_2014_70				
Comment Code					
V2 : Remove the wild growth other than native grasses from the levee slopes.					
Inspector Comment					
District need to remove the wild growth from the waterward levee slope and shoulder.

Unsatisfactory growth of young tree growth present on the waterside levee slope.

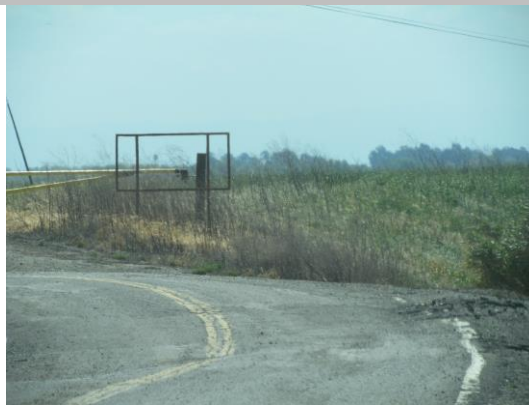
Photo 1 of 1 : SP_2016_RD0536_209_8_20160516_00017.jpg

LM Start	0.11	Rating **	U	Issue No.	8
LM End	4.48	Issue Type +	Ma	Location *	LS
Category	Earthen Levee			GPS Latitude/Longitude	
				Start	End
Item	Vegetation			38.244040 °	38.197090 °
				-121.696950 °	-121.701027 °
DWR ID	DWR_RD0536_02_s_2016_8				
Comment Code					
V1 : Control annual grass and weeds on the levee slopes and easements.					
Inspector Comment					
Control the tall weeds on the landside levee slope and toe, there haven't been any maintenance done on this section of levee.

RD 536 Unit 2 looking downstream from levee mile 0.11 to 4.48 tall weeds completely covering the landside levee slope.

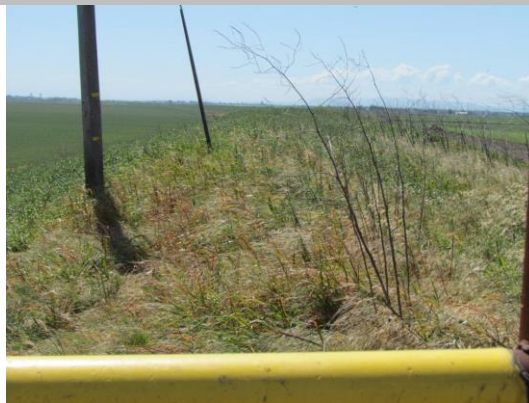
Photo 1 of 1 : SP_2016_RD0536_209_15_20160516_00020.jpg

LM Start	0.11	Rating **	U	Issue No.	15
LM End	2.17	Issue Type +	Ma	Location *	CR
Category	Earthen Levee			GPS Latitude/Longitude	
				Start	End
Item	Vegetation			38.243965 °	38.214507 °
				-121.696933 °	-121.693970 °
DWR ID	DWR_RD0536_02_f_2015_15				
Comment Code					
V9 : Keep the crown roadway free of vegetation.					
Inspector Comment					
The crown roadway should be free from vegetation at all times.

RD 536 Unit 2 levee mile 0.11 - 0.86 crown roadway overgrown with tall weeds.

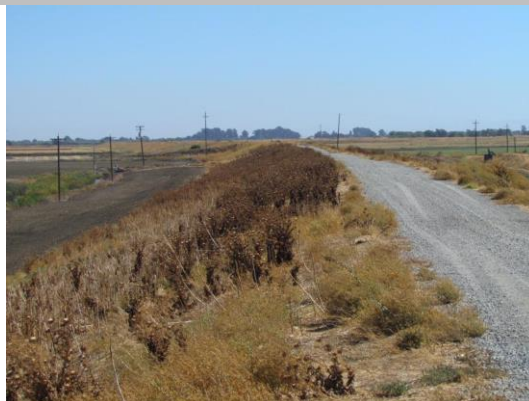
Photo 1 of 1 : SP_2016_RD0536_209_2_20160223_00001.jpg

LM Start	2.17	Rating **	U	Issue No.	2
LM End	4.36	Issue Type +	Ma	Location *	WS
Category	Earthen Levee			GPS Latitude/Longitude	
				Start	End
Item	Vegetation			38.214579 °	38.196442 °
				-121.693950 °	-121.698978 °
DWR ID	DWR_RD0536_02_f_2015_2				
Comment Code					
V2 : Remove the wild growth other than native grasses from the levee slopes.					
Inspector Comment					
Remove the dead weeds from the waterward levee section.

Unsatisfactory wild growth of weeds on the waterside levee slope and shoulder.

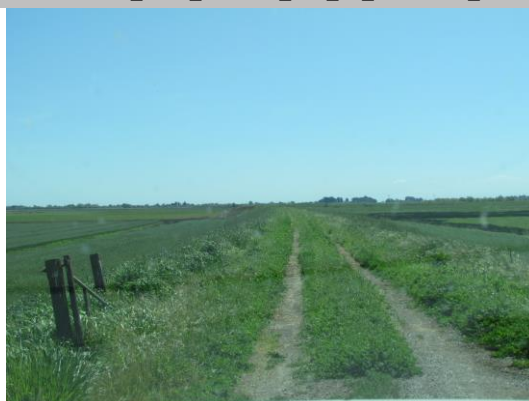
Photo 1 of 1 : SP_2016_RD0536_209_13_20160516_00021.jpg

LM Start	2.61	Rating **	U	Issue No.	13
LM End	4.38	Issue Type +	Ma	Location *	CR
Category	Earthen Levee			GPS Latitude/Longitude	
				Start	End
Item	Vegetation			38.208542 °	38.196558 °
				-121.690903 °	-121.699284 °
DWR ID	DWR_RD0536_02_s_2016_13				
Comment Code					
V1 : Control annual grass and weeds on the levee slopes and easements.					
Inspector Comment					
Mow and spray the crown roadway to keep it free of vegetation.

RD 536 Unit 2 looking downstream from levee mile 2.61 - 3.60 crown roadway.
